Site Inspection Reassessment
San Vicente Creek Mill
CERCLIS #: NMD980879415
Grant, County New Mexico

September, 2010

Superfund Oversight Section
Ground Water Quality Bureau
New Mexico Environment Department

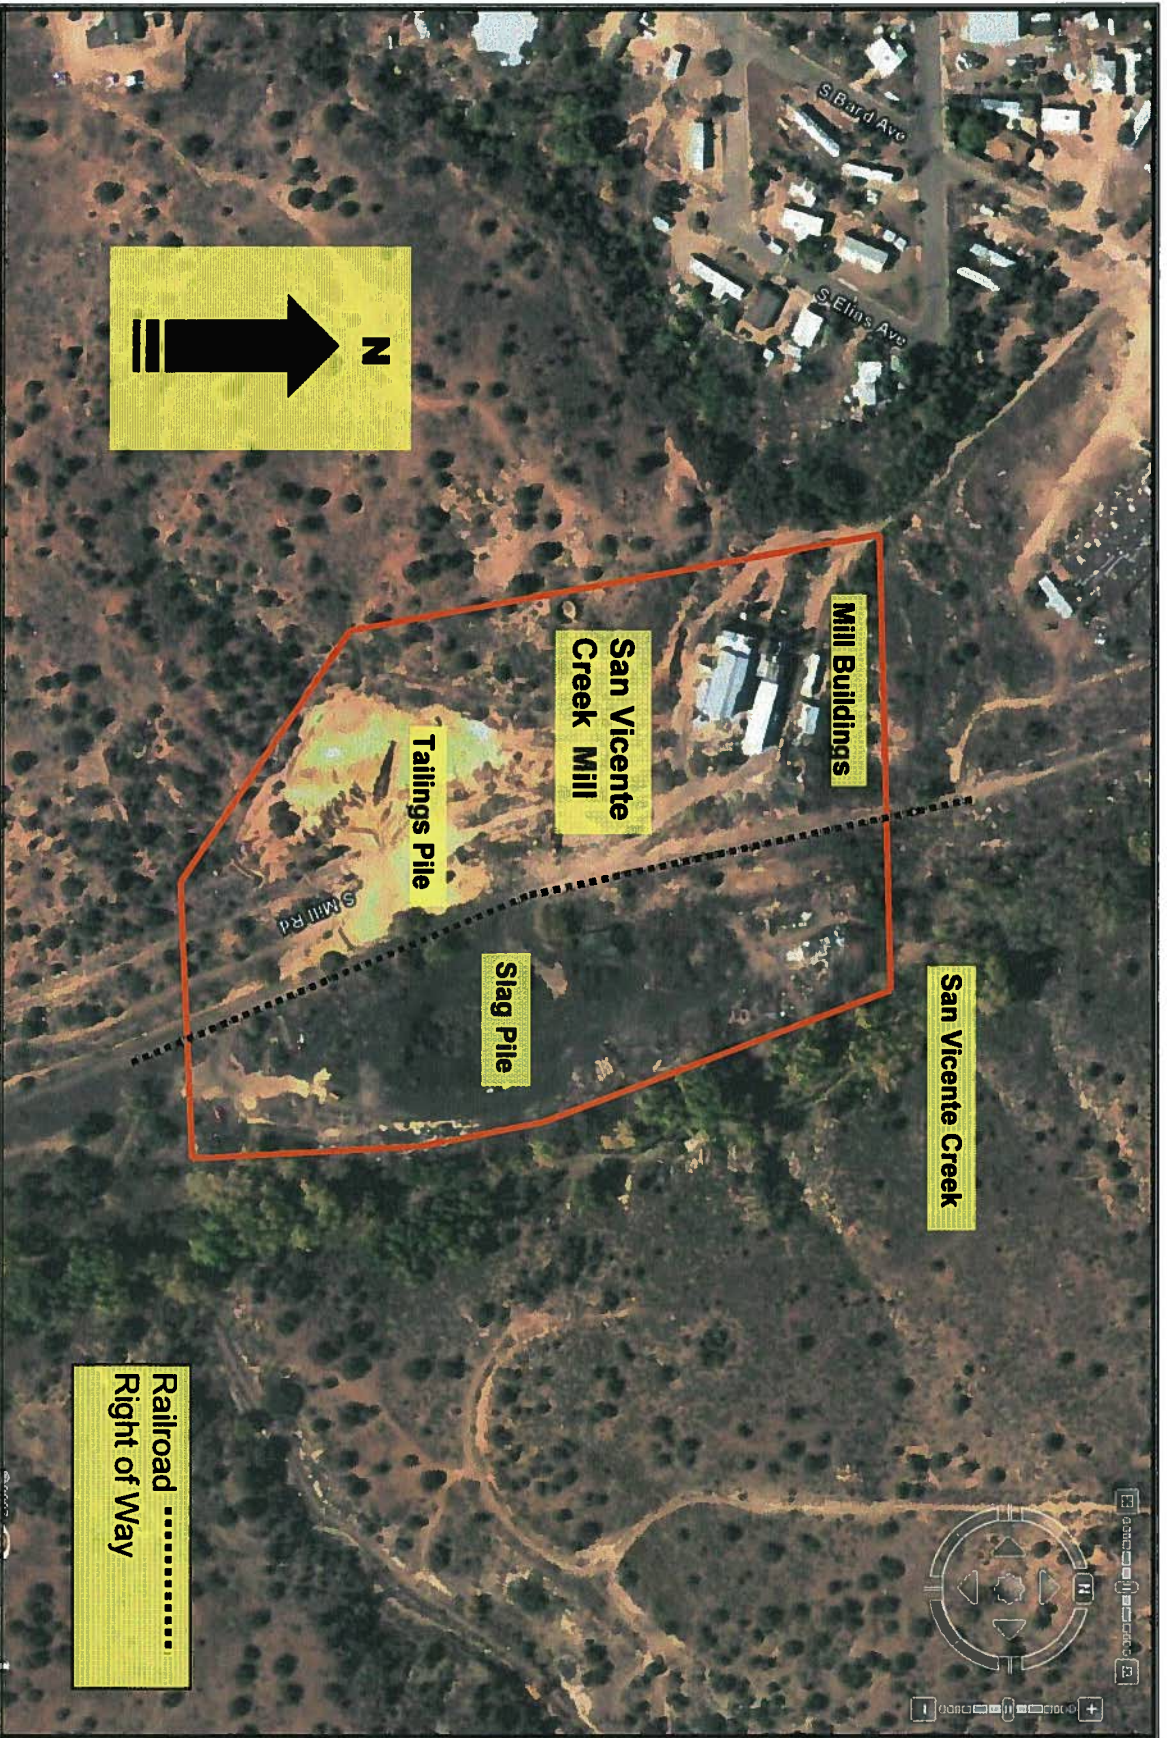
Figure 2. San Vicente Creek Mill Site, Silver City, New Mexico, Ref 41

colored sandy tailings that is located west of the slag material and the railroad right of way. Both waste sources are located south of the existing mill buildings on the mill site (Figure 2).

There are no residences or schools within 200 feet of the mill site waste sources (Figure 2). The closest residence to the site is approximately 400 feet to the northeast (Figure 2). Mr. Horton has several workers at the site presently and two residents that live on-site and function as watchmen (Ref. 17, p. 1). Mr. Horton maintains a fence and locked gate on the north-side of the mill site. A steep hill on the west-side of the mill site makes access difficult. The south-side of the mill site can be accessed from the railroad right of way. Mr. Horton has blocked the railroad right of way with old heavy turbines that make vehicular access to the site impossible (Ref. 9, p. 1, 7). Foot traffic is possible but less likely with watchmen on-site. "No Trespassing" signs are posted across the road entering the property and the railroad right of way. No trespassers were observed during all site visits in 2008 and 2009. Several warehouse and industrial sites are north of the mill site. A small residential area is located along the western boundary separated by a steep hill and undeveloped land. Another small residential area is located southwest of the site and is also separated by undeveloped land. East of the mill site is a steep hill with several houses on the ridge. Several hiking trails are evident on the hill side.

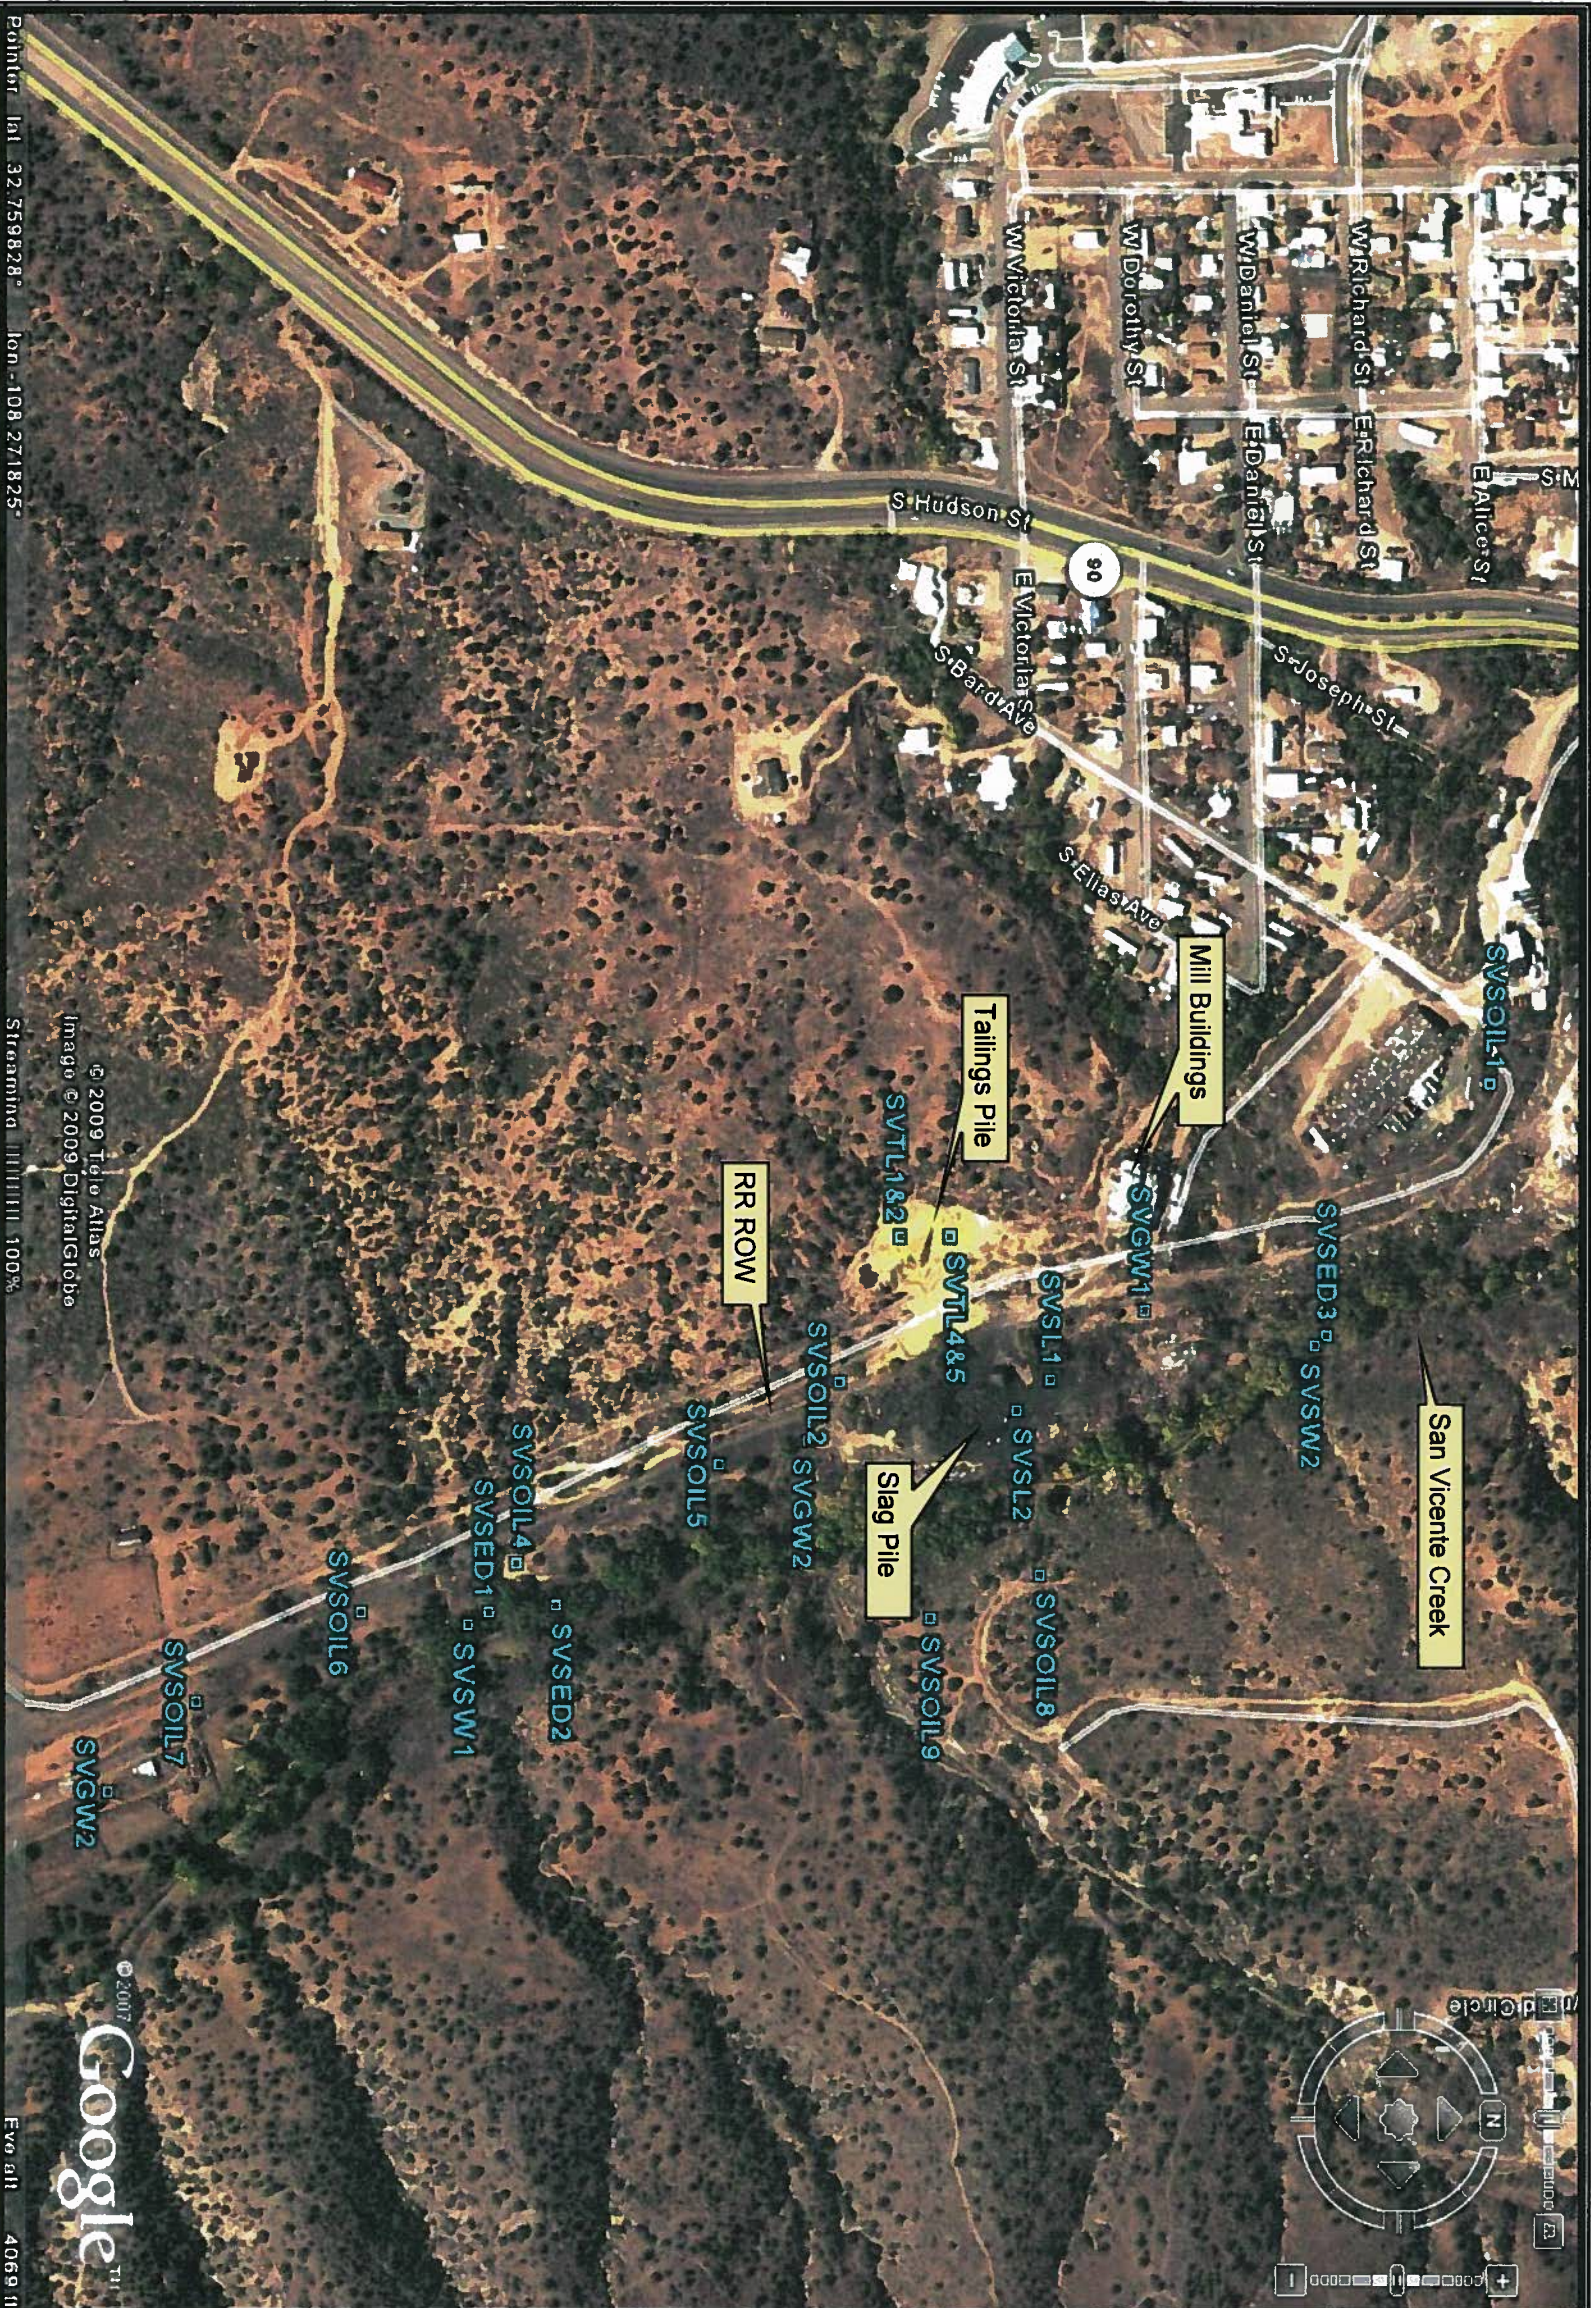
Figure 3. San Vicente Creek Mill Sample Locations, Ref 41

During the SIR, on June 2 and June 3, 2009, samples were taken of the tailings and slag piles to identify CERCLA hazardous substances (Figure 3). Samples were collected using a stainless steel hand held shovel and placed in 8 oz glass sample containers. Samples were analyzed for Target Analyte List (TAL) metals including cyanide and mercury under the Environmental Protection Agency's Contract Laboratory Program (CLP).

Two locations were selected to sample on the slag pile (Figure 3). Slag material was excavated to a maximum depth of six inches and screened through a 2 mm mesh until the sample container was appropriately full. A total of two slag samples were collected.

Two locations were selected to sample on the tailings pile (Figure 3). At each location a total of two tailings samples were collected. At each location the first sample was collected at a depth of 6 inches followed by further excavation of the tailings with the second sample collected at a depth of 24 inches. A total of four tailings samples were collected. The tailings are predominately a sandy material (<2 mm) so the tailings sample were not passed through a 2 mm mesh.

During the SIR, nine soil samples were taken to determine areas of contaminated soil (Figure 3). Samples were collected within the top six inches of soil. Two samples (SVSoil2 and SVSoil4) were taken off the mill site down gradient of the perimeter berm from areas that were visibly contaminated with mine tailings, as described in Sections 3.1.1 and 3.3.3. SVSoil2 was taking in the drainage ditch along railroad right of way and SVSoil4 was taken on the floodplain along San Vicente Creek. Two samples (SVSoil8 and Soil9) were taken east of the mill site and San Vicente Creek on the hill side. The remaining soil samples (SVSoil5, SVSoil6 and SVSoil7) were collected between the railroad right of way and San Vicente Creek down to the Slout Farm property. One background sample (SVSoil1) was collected just north of Mr. Horton's operation, in an idle field. All soil samples were shipped to an EPA CLP laboratory for analysis of TAL metals including cyanide and mercury according to EPA SOW5.2.

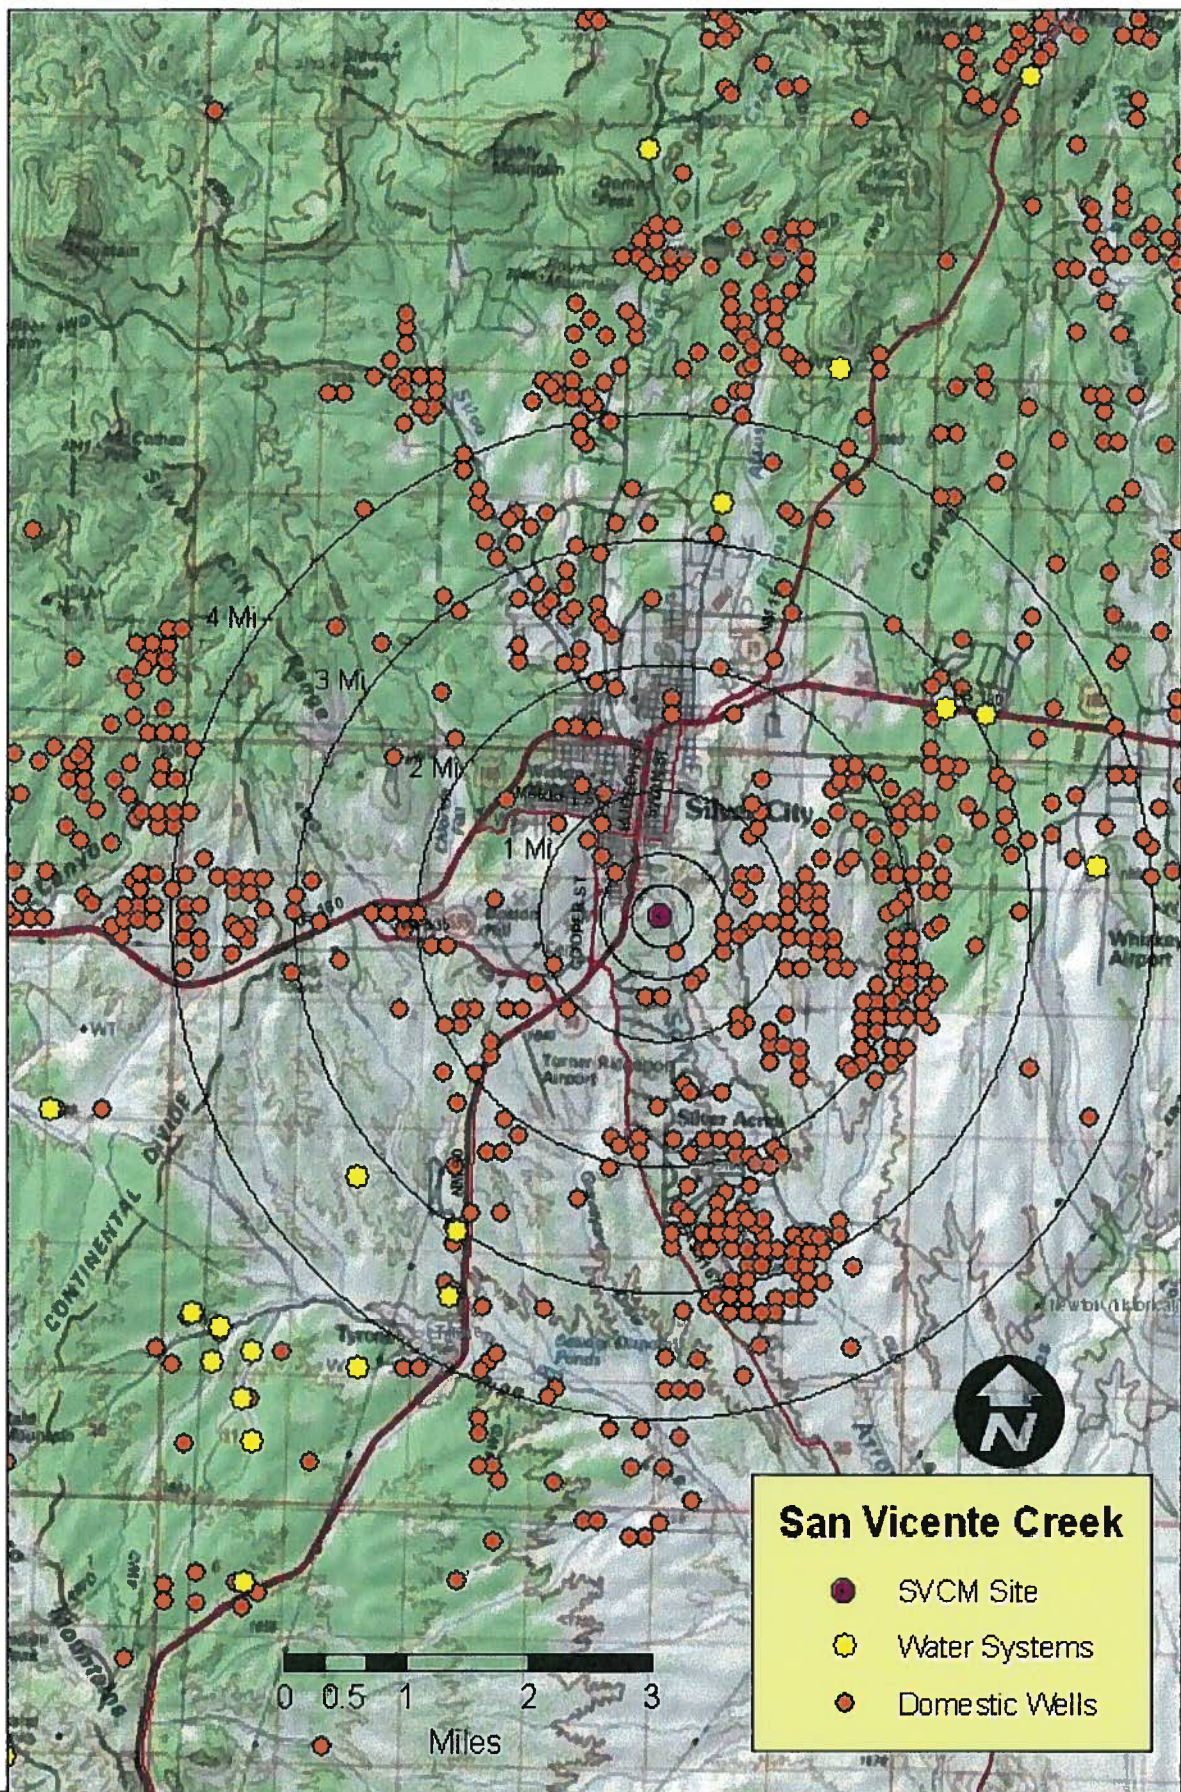
Figure 4. San Vicente Creek Mill, Drinking Water Wells within the TDL, Ref. 27 and Ref. 40

present within the TDL of the mill site. The search identified 475 registered domestic well within the four miles of the mill site (Ref. 27, p. 23). The number of people using domestic wells within the TDL was determined by multiplying the number of domestic wells in the TDL by 2.5, the average number of people per household in Grant County, New Mexico as measured by the 2000 United States Census (Ref. 28, p. 1). A population of 1,188 people is estimated to use ground water for drinking purposes from private wells within the TDL of the mill site.

One Town of Silver City drinking water system well is located within the TDL (Ref 25 and 26). The Town of Silver City drinking water system has a total of 12 wells and is a blended system with no well providing more than 40 percent of the total drinking water supplied. The TOSV drinking water system serves 18,615 people (Ref. 29, p. 1). In addition there are 4 mutual domestic water associations (MDWA) and the town site of Tyrone that purchase their drinking water from the Town of Silver City drinking water system for a total of 3,239 additional users (Ref. 29, p. 3-7). That is a total population of 21,854 (18,615 + 3,239) that is provided drinking water by the Town of Silver City water system. Given the above total population of 21,854 and 12 wells, one Town of Silver City well may serve approximately 1,821 ($21,854 \div 12$) people. Figure 4 shows the location of all domestic supply wells within the TDL a four-mile radius of the mill site. Table 4 summarizes the number of people utilizing ground water for domestic purposes within each TDL.

Finally it is recommended that further investigation is needed to evaluate levels of actual contamination at targets through exposure from the ground water and soil pathways. Therefore, the additional sampling of domestic wells and residential soil down-gradient of the mill site is recommended.
