Site Characterization Report Pinos Altos Mining District Grant County, New Mexico

CERCLIS Number: NMN000606749
Contract Number: W9126G-06-D-0025
Task Order Number: 0005

May 2009

Subj: Site Characterization Report: Pinos Altos Mining District
Pinos Altos, Grant County, New Mexico
Contract No. W9126G-06-D-0025
Task Order No. 0005

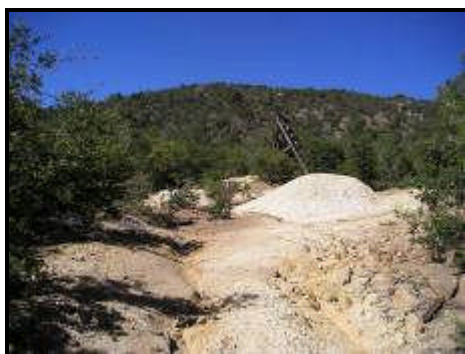
Bullion claim

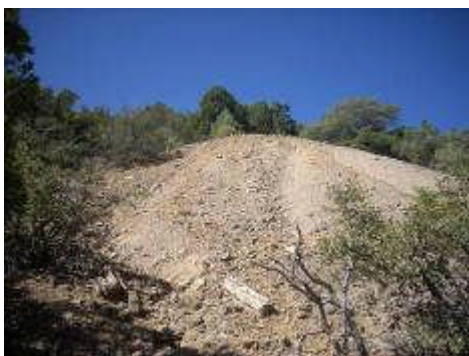
Waste rock on Ohio claim

Cd. The yellow-gray waste rock pile lacks vegetation (Appendix E, photographs 559-562 and 565-567), had a pH of 3.8 units and has an estimated volume of 7,700 yd³.

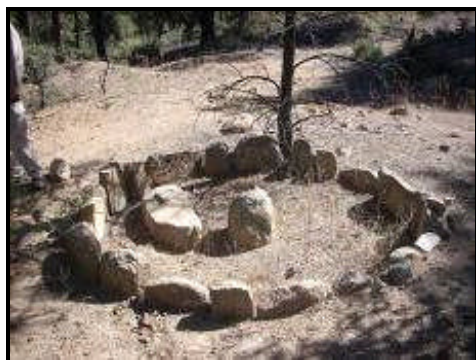
Well preserved arrastra at Location 307

Location 307 is on BLM property east of the Gray Eagle claim (Appendix G, Map G-1). The site consists of a series of small test pits or collapsed shaft with an associated small waste pile (Appendix E, photographs 701-706). Sample 307 slightly exceeds residential screening levels for Pb and As (Appendix F, Table F-1). Estimated volume is approximately 350 yd³. Of additional interest at this site is the presence of a well preserved arrastra (Appendix E, photographs 699 and 700).

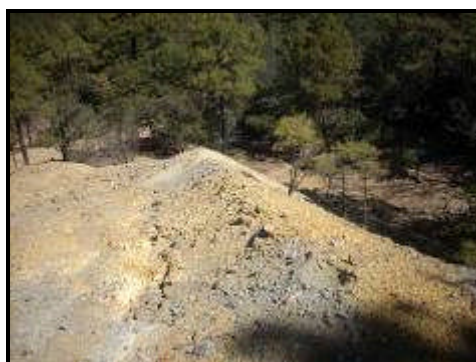
Location 215 – Waste pile on north tract of Mogul (MS 796)

Location 215 is located on the north tract of the Mogul (MS 796) claim, adjacent to the dirt access road (Appendix G, Map G-2). The site consists of a collapsed shaft and large yellow-orange waste pile (Appendix E, photographs 472-475 and 101002-101004). Field screening of the material produced a pH of 4.2 units (Appendix F, Table F-4). Sample 215 exceeds residential screening levels for Pb and As and has an estimated volume of 10,950 yd³. Elevated metals in samples 216 and 217, collected in the drainage down gradient of Location 215 (Appendix E, photographs 476- 479), apparently documents surface water transport of the mine waste (Appendix F, Table F-1).

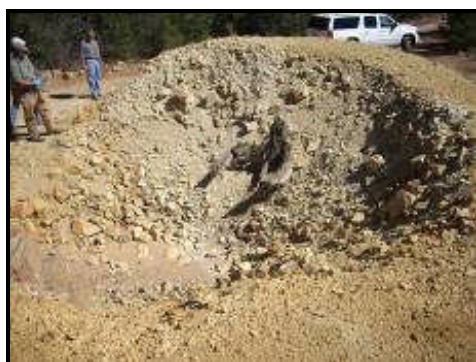
Collapsed shaft and waste rock at Location 214

Location 214 consists of a yellow-orange waste rock pile and collapsed shaft (Appendix E, photographs 469-471 and 101001). The waste pile exceeds recreational Pb screening levels and is adjacent to a commonly used dirt road to the Mogul (MS 796) and other claims. Field screening produced an acidic pH of less than 3.5 units (Appendix F, Table F-4). Waste volume is approximately 850 yd³.

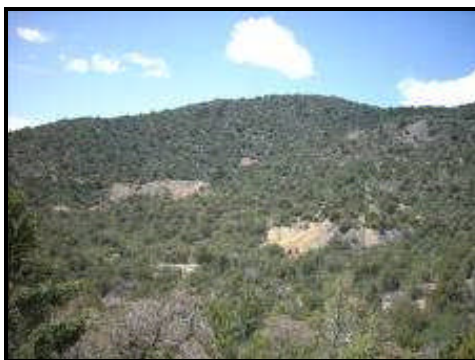
Large waste rock piles on the east side of Pacific Ridge

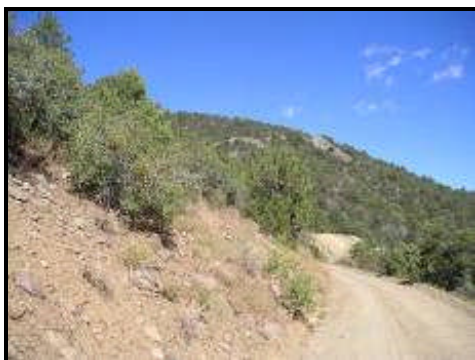
Waste rock associated with the Hearst Shaft (left) and Aztec claim (right)

Location 157, characterized by samples 157 and 158, is located on the southern portion of the Aztec claim, up gradient of the Hearst Shaft, on the Pacific claim. The site consists of a collapsed shaft and very large waste rock pile (Appendix E, photographs 375-379 and 1010021) which extends approximately 300 feet down slope. Sample results from the waste rock pile exceed recreational Pb and residential As screening levels (Appendix F, Table F-1). The waste pile consists of coarser gray rock covering orange, finer grained material and is likely analogous to desert pavement, where wind removes finer grained material leaving coarse particles as a covering to the soil. The estimated volume is 130,900 yd³.

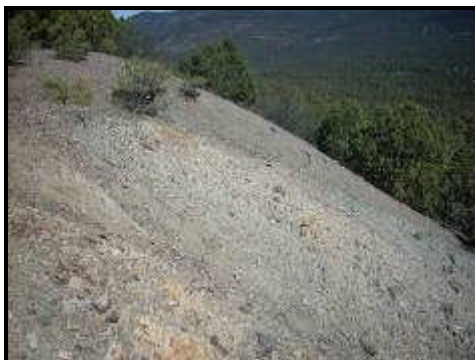
Detail of waste rock associated with the Hearst Shaft

Location 155, characterized by samples 155 through 159, is located southwest of and down gradient to the Aztec waste rock pile (Appendix G, Map G-4). The site consists of waste rock associated with the Hearst Shaft (Appendix E, Photographs 367-374, 380-385, and 1010024-1010028), which originated on the on the Pacific claim and extends onto the Globe Democrat claim. Based on field screening results, the material has a pH of 3.6 units (Appendix F, Table F-4). Sample results exceed recreational screening levels for Pb and As (Appendix F, Table F-1). The estimated volume is 42,000 yd³. The shaft head frame is present and recreational visitors to the shaft were observed on several occasions during the assessment. Material from this claim also extends down gradient via Maudes Canyon Arroyo (samples 160 and 161) to the Pacific Fraction No. 2 and Montana claims.

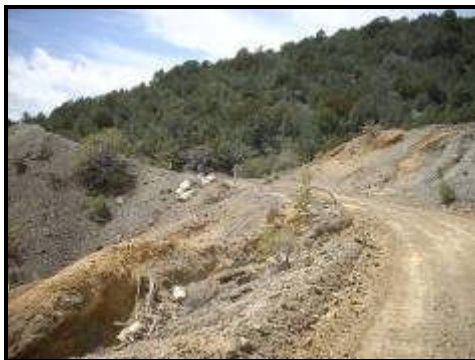
Radio Tower Road crossing mine waste on Montana claim

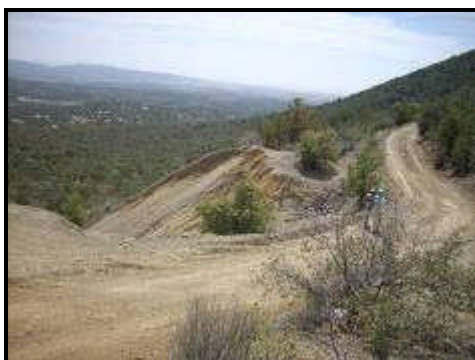
A significant volume of mine waste with characteristics typical of ARD is present on the Montana claim within Maudes Canyon Arroyo (Appendix E, photographs 392-403). In addition, the material is bisected by Radio Tower Road, which facilitates access and exposure to the material. Recreational usage by the public is common. Field screening of the material produced pH values ranging from 4.6 to 3.4 standard units (Appendix F, Table F-4) Analyses of samples 165-169, 171-176, 266-269, and 271 document concentrations above screening levels for Pb, As, and/or Cd (Appendix F, Table F-1). The estimated volume of the mine waste present on the Montana claim is in excess of 115,000 yd³.

Radio Tower Road crossing mine waste on Montana claim

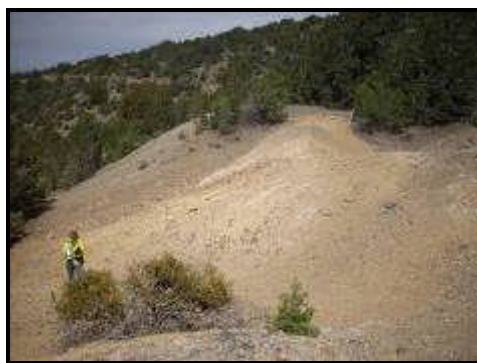
**Waste rock on the Pacific Fraction
No. 2 claim**

A large waste rock pile, characterized by samples 151-153, was identified on the steep slope of the southern portion of the Pacific Fraction No. 2 adjacent to the dirt access roads extending from Radio Tower Road (Appendix E, photographs 360-365; Appendix G, Map G-4). The waste pile is yellow to orange to gray in color with a pH of approximately 3.8 units, and exceeds recreational screening levels for Pb in sample 153 and residential screening levels for Pb, As, and Cd in all three samples (Appendix F, Tables F-1 and F-4). There is a collapsed shaft and scattered support timbers at the site. The thin trail that crosses the pile and leads to the Globe Democrat claim appears to be the former narrow gauged railroad track. The estimated volume for the waste rock pile is 14,500 yd³ (Table 3). Surface water from Locations 288 and 151 drains east-southeast and join Maudes Canyon Arroyo down gradient of the Manhattan claim.

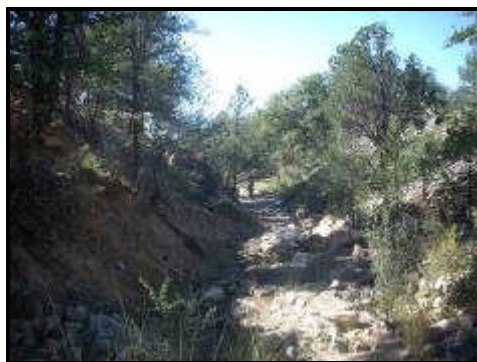
Down gradient of the Manhattan claim, Maudes Canyon Arroyo crosses BLM land and the Graystone (MS 1472), Deer Field (MS1472), Southern Slope (MS 1568) and the southwest corner of the Bullion (MS 795) claims (Figure 2; Appendix G, Map G-3). In this area, the slope has decreased substantially and no extensive mining waste was observed (Appendix E, photographs 410-412). Mine waste related to the Bullion claim is drained by a separate system and will be discussed with the east margin claims. Sample 182, collected from within the drainage on the Graystone claim, exceeds residential screening levels for Pb and As and was the only sample from this area with a Pb concentration above the screening level. In addition to sample 182, samples 183, 185, 191-194, 204, 210, and 212 had concentrations above the residential As screening level (Appendix F, Table F-1; Appendix G, Maps G-5 through G-8). The sediment is slightly acid to neutral with pH values ranging 4.6 to 6.5 units (Appendix F, Table F-4). Adjacent to this drainage, near Location 208, a mine shaft was noted (Appendix E, photographs 648-649). Samples collected outside of Maudes Canyon Arroyo, samples 201 through 209, 211 and 213, did not exceed screening levels.

Maudes Canyon Arroyo at Sample Location 208

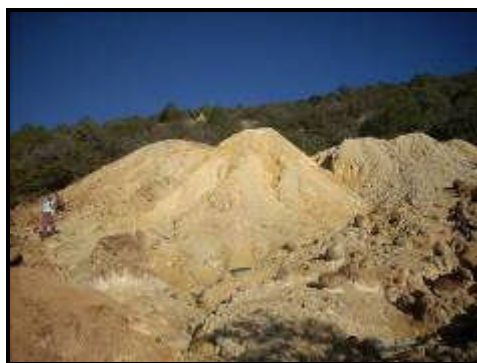
Mina Grande lower waste piles

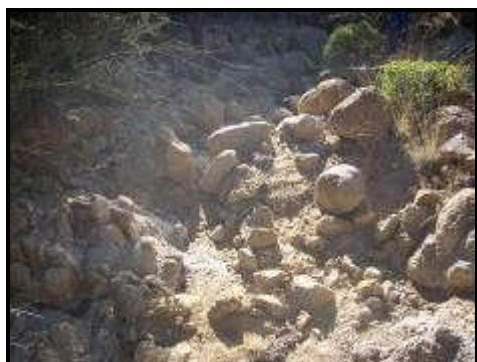
Drainage down gradient of the Mina Grande waste piles. Note salts.

With respect to the east portion of the Maudes Canyon drainage, mining waste with Pb, Cu, As, and/or Cd concentrations above assessment levels was documented on the Mina Grande and Bullion claims and BLM property (Appendix F, Table F-1; Appendix G, Maps G-5 through G-11). Because of access issues, complete assessment of the Mina Grande claim was unable to be performed and the lower waste pile (Appendix E, photograph 696) was unable to be included in the XRF survey. Limited samples were collected from the Radio Tower Road right-of-way, which cuts across the upper Mina Grande waste pile (Appendix E, photographs 613-615). Analysis of samples 262-265 document that the roadway portion of the pile exceeds recreational screening levels for Pb and residential screening levels for As (Appendix F, Table F-1). The Mina Grande waste piles consist of light yellow to orange material with an estimated volume of 30-35,000 yd³ for both piles. Both piles drain to the east and southeast. Samples 199, 225, 226, and 277 (Appendix F, Table F-1; Appendix G,

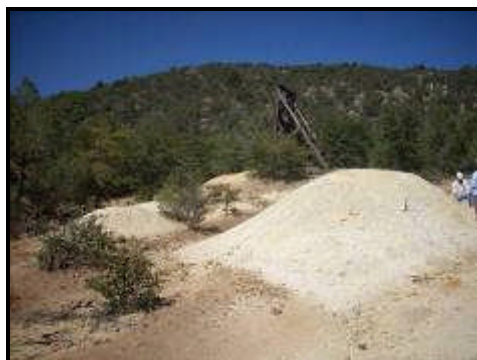
The Bullion claim is located south of the Mina Grande claim and is easily accessible from Highway 15. During the field activities, recreational use visitors were observed on the Bullion and adjacent BLM property. Like the Mina Grande waste piles, the material has characteristics of ARD and drains to the east and southeast. Several structures related to the mining operations, including the mine shaft and head works, are still present and pose a significant physical threat, as well as an attractive nuisance (Appendix E, photographs 633-635, 683, 687, 688, 690, 692, and 1010035-1010039). Many of the samples from the Bullion claim exceed recreational screening levels for Pb and/or residential levels for As (Appendix F, Table F-1, samples 274, 295-297, 299, and 300-306; Appendix G, Maps G-5 through G-11). Lead concentrations range from background concentrations outside of disturbed areas (sample 304) to greater than 5,000 ppm in mine waste (sample 298). Arsenic ranged from below instrument (XRF) detection limits to 141 ppm (sample 298). Confirmation laboratory analysis of sample 298 contained Pb and As concentrations of 12,800 and 56 ppm, respectively (Appendix F, Table F-2). Mine waste associated with the Bullion claim is estimated to exceed 38,000 yd³ (Table 1). Drainage samples 272 and 305 document surface water transport of waste material east, onto adjacent BLM property.

Mining waste on Bullion claim

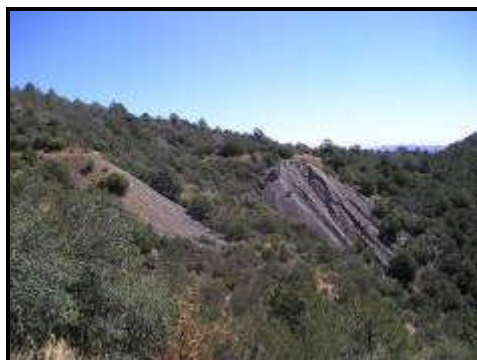
Waste rock on the Pacific Fraction and Colorado claims.

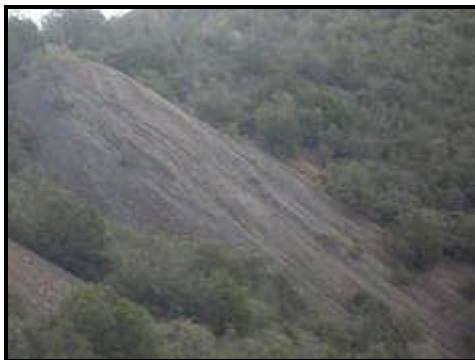
A large waste rock pile, characterized by samples 132 through 134 and 138 through 140 was located near the northeast corner of the Colorado claim (Appendix E, photographs 311-315, 319, 324-331, 337, and 338; Appendix G, Map G-4). The waste pile is on a very steep slope, orange-brown to gray in color with a pH of approximately 4.6 units, and exceeds screening levels for Pb, As, and Cd (Appendix F, Tables F-1 and F-4). The estimated volume

Waste Rock near northeast corner of the Colorado claim

for the waste rock pile is 52,360 yd³. Sample 141, adjacent to the waste rock (Appendix E, photographs 332-334) did not exceed screening levels.

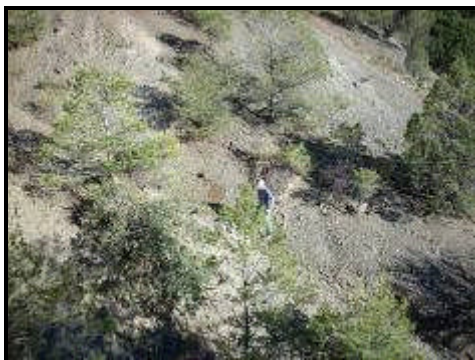
Location 129, characterized by samples 129 through 130, is a large waste rock pile on a steep slope (Appendix E, photographs 308, 309, and 1010021). The waste rock is gray and exceeds residential screening levels for Pb and/or As (Appendix F, Table F-1). Estimated volume is in excess of 120,000 yd³.

Sampling at Location 129

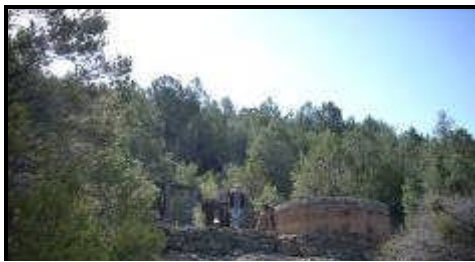
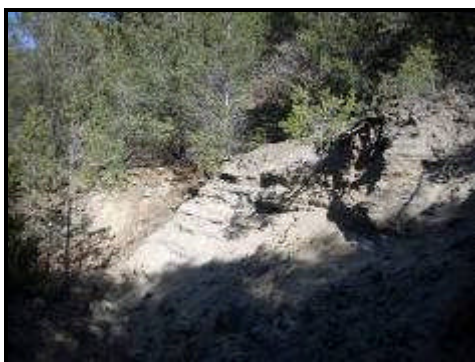
Mill tailings in Pinos Altos Creek

In addition to the afore mentioned waste rock piles, structures and process waste, such as slag and mill tailings related to the Hearst Mill are present on the Pacific No. 2 and South Extension of the Pacific claim (Appendix E, photographs 272-283, 1010017, and 1010018). The upper mill area, characterized by samples 101, 102, 103, and 105, exceeds recreational screening levels for Pb and residential levels for As and/or Cd (Appendix F, Table F-1). The lower mill area contains brick structures and appears to be where mill tailings were released into the Pinos Altos Creek drainage system. Samples of the upper mill area (samples 105-108) tailings exceed recreational and/or residential screening levels for Pb, Cu, Zn, As, and Cd (Appendix F, Table F-1). The large mine shaft located in the Tampico claim, north of the Pinos Altos channel, is

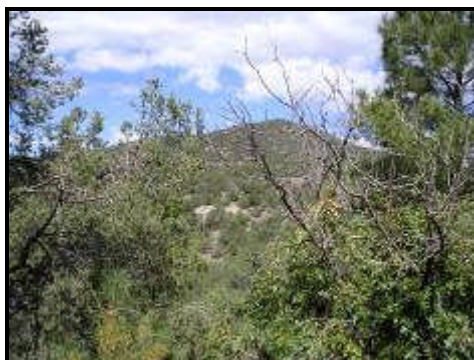
A large waste rock pile, characterized by samples 145 through 149, was located near the southern margin of the Pacific Fraction No. 2 claim (Appendix E, photographs 346-355; Appendix G, Map G-4). The partially vegetated waste pile is on a steep slope, gray to orange-brown in color, and exceeds screening levels for Pb, As, and Cd (Appendix F, Table F-1). The estimated volume for the waste rock pile is 26,180 yd³.

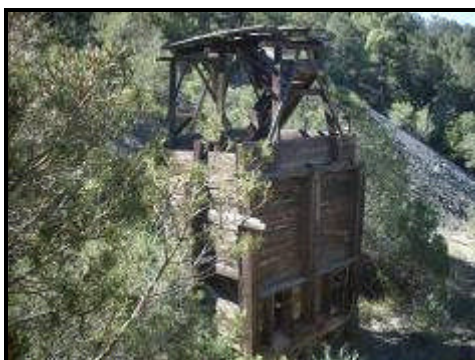
Mining operation structures and a large waste rock pile, characterized by samples 255-257 were located on non-patented land west of the Pinos Altos/Langston claims (Appendix E, photographs 600-609, 664, 665, and 1010008; Appendix G, Map G-4). The gray waste pile is situated on a steep slope and exceeds recreational screening levels for Pb and/or residential screening levels for As and Cd (Appendix F, Table F-1). The estimated volume for the waste rock pile is 6,000 yd³.

Mining structures and waste rock at Location 255
